**Flood Control Project Maintenance
Levee Inspections**

Maintenance Issue Types Only, Levee Inspection Report By Mile - Spring 2019

Reclamation District No. 2031 Elliot

Waterway	Bank	Unit Miles	Inspection Start/End	Inspector
Unit No. 01 Stanislaus River	Left	7.07	05/16/2019 05/16/2019	Alberto De Leon

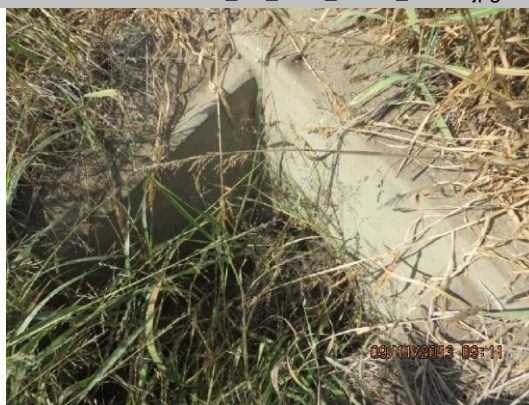
Photo 1 of 2 : UCIP_SP_2019_20024_33924.jpg

Concrete headwall on LS slope.

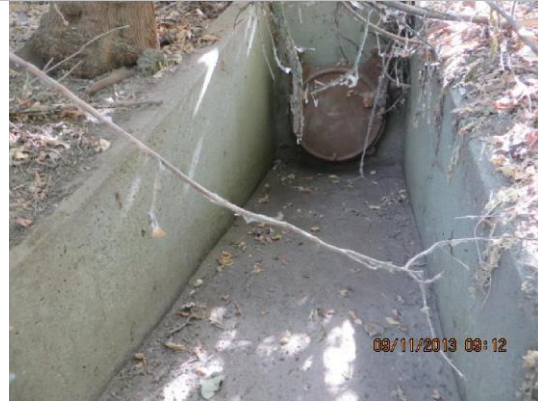
Photo 2 of 2 : UCIP_SP_2019_20024_33923.jpg

Concrete headwall and flapgate on WS toe.

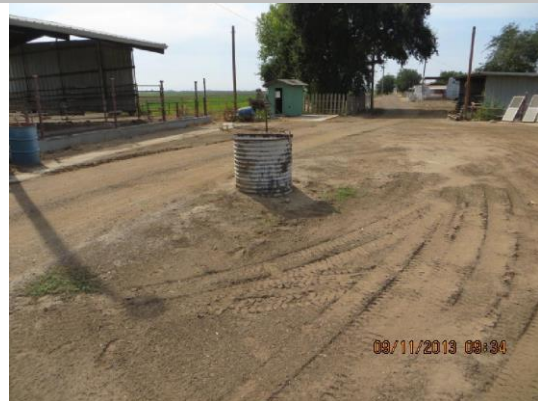
Photo 1 of 3 : UCIP_SP_2019_20044_33942.jpg

36-inch CMP riser on WS shoulder.

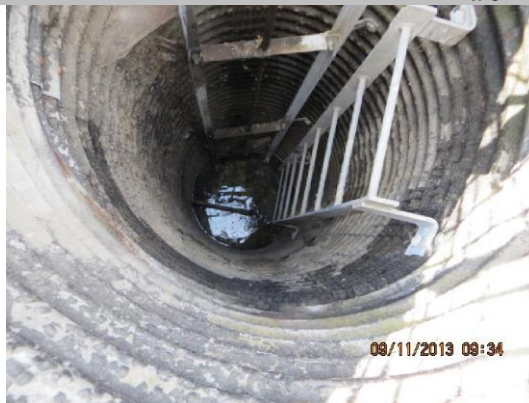
Photo 2 of 3 : UCIP_SP_2019_20044_33941.jpg

Slide gate in CMP riser on WS shoulder.

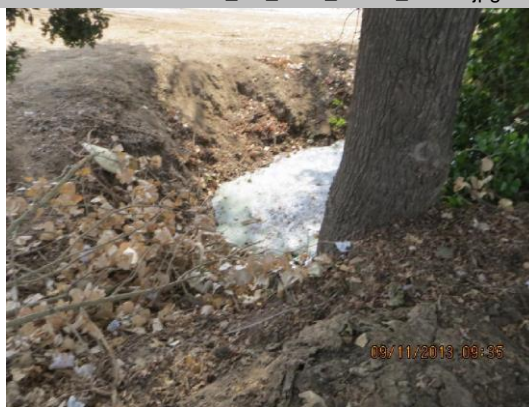
Photo 3 of 3 : UCIP_SP_2019_20044_33940.jpg

Drainage ditch at inlet on LS toe.

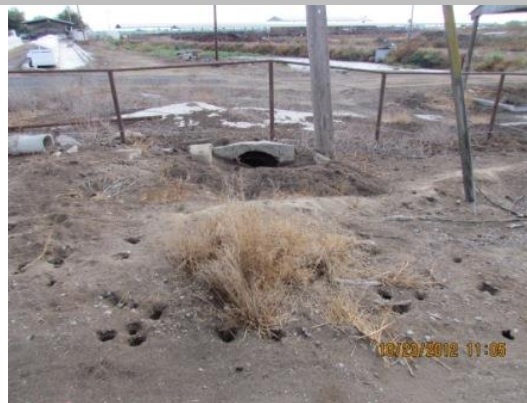
Photo 1 of 1 : SP_2019_RD2031_307_36_20190313_00008.jpg

View of rodent burrows on landside slope.

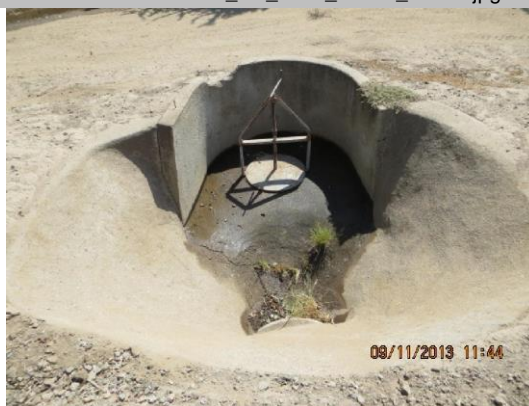
Photo 1 of 3 : UCIP_SP_2019_20088_34030.jpg

Bowl shaped concrete inlet on LS slope.

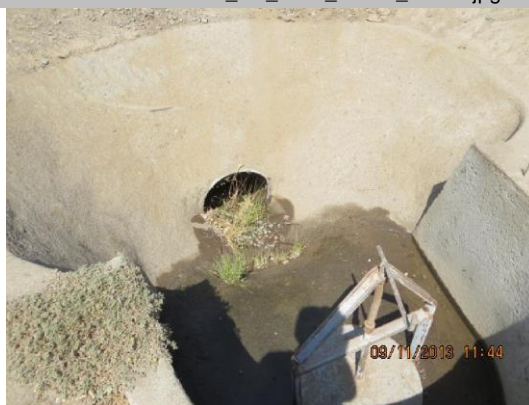
Photo 2 of 3 : UCIP_SP_2019_20088_34029.jpg

Bowl shaped concrete inlet on LS slope.

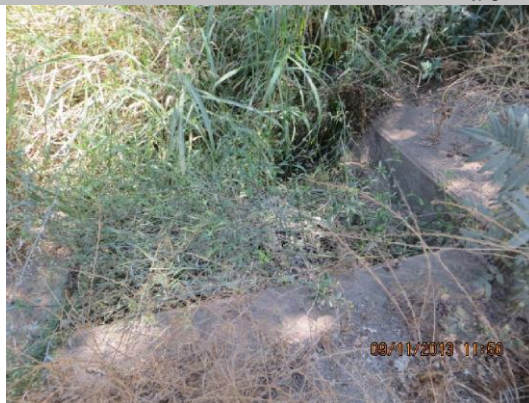
Photo 2 of 3 : UCIP_SP_2019_41354_34033.jpg

Concrete headwall on LS toe.

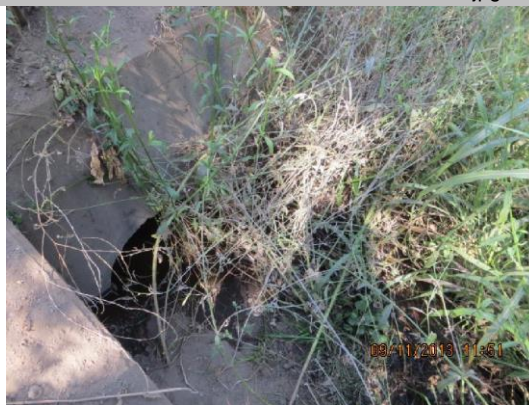
Photo 3 of 3 : UCIP_SP_2019_41354_34032.jpg

Concrete headwall at LS toe.

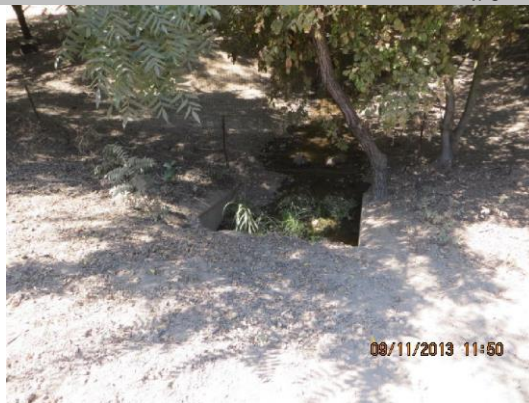
Photo 1 of 3 : UCIP_SP_2019_20092_34041.jpg

Concrete U-shaped headwall on WS toe.

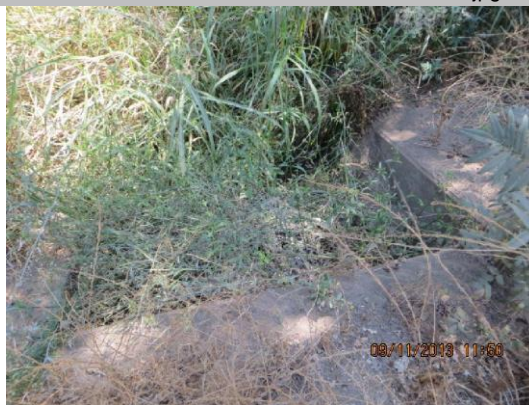
Photo 2 of 3 : UCIP_SP_2019_20092_34040.jpg

Concrete U-shaped headwall on LS toe.

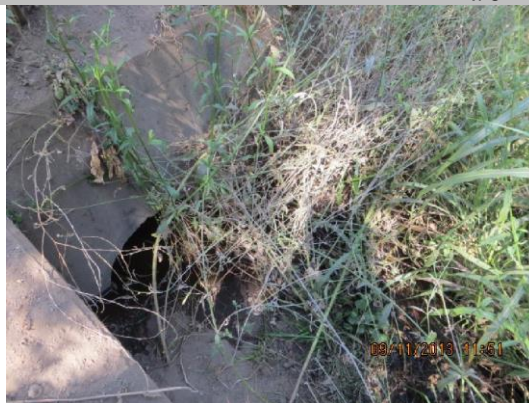
Photo 3 of 3 : UCIP_SP_2019_20092_34039.jpg

Concrete U-shaped headwall on LS toe.

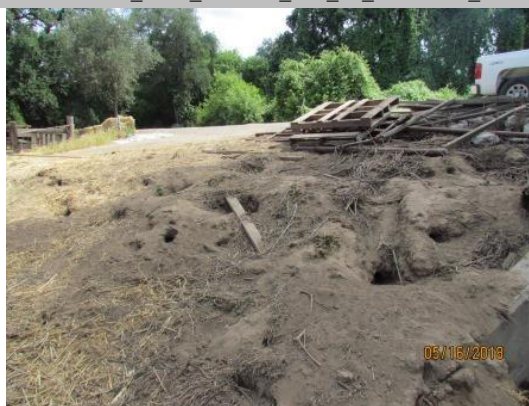
Photo 1 of 1 : SP_2019_RD2031_307_49_20190313_00013.jpg

View of the waterside where several squirrel holes are and active rodent activity.

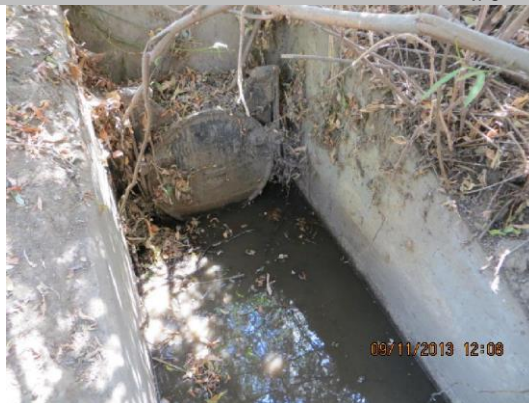
Photo 1 of 3 : UCIP_SP_2019_20110_34078.jpg

Flapgate and concrete headwall on WS toe.

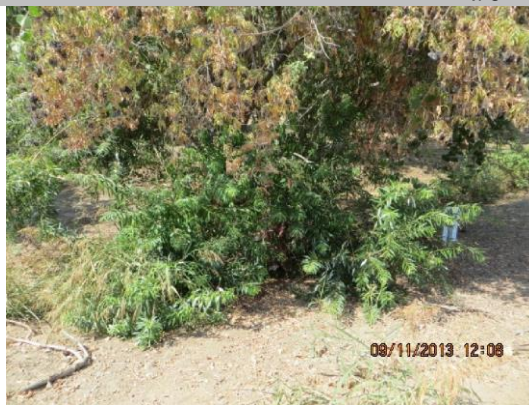
Photo 2 of 3 : UCIP_SP_2019_20110_34077.jpg

Vegetation covers outlet of pipe on WS slope.

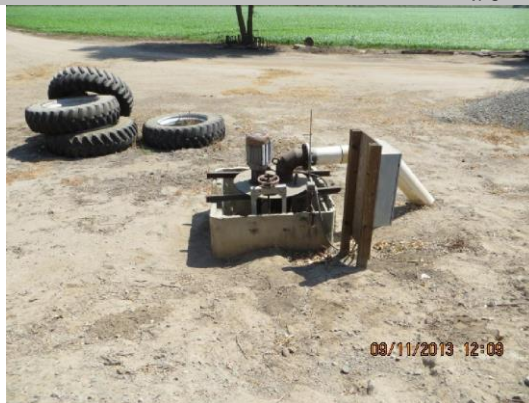
Photo 3 of 3 : UCIP_SP_2019_20110_34076.jpg

5'X5' concrete riser with pump on LS toe.

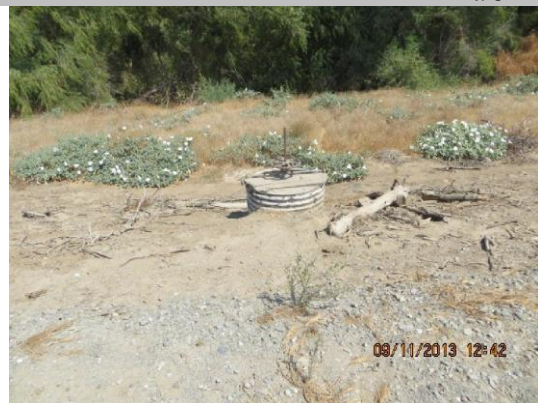
Photo 1 of 3 : UCIP_SP_2019_20449_34506.jpg

Slide gate in CMP riser on WS slope.

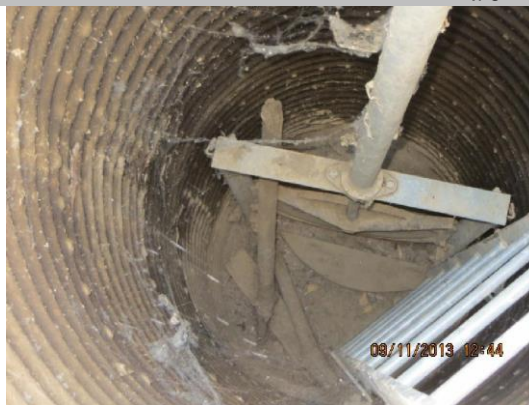
Photo 3 of 3 : UCIP_SP_2019_20449_34504.jpg

Slide gate in CMP riser on WS slope.

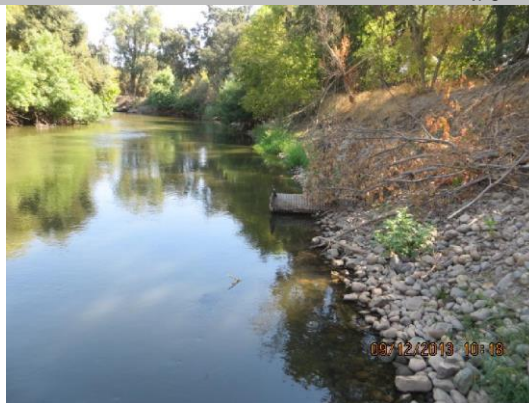
Photo 1 of 2 : UCIP_SP_2019_23064_39200.jpg

CMP pipe and flapgate visible at WS toe.

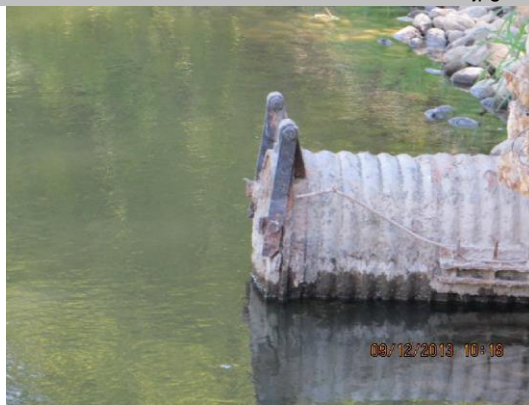
Photo 2 of 2 : UCIP_SP_2019_23064_39199.jpg

CMP pipe and flapgate visible at WS toe.

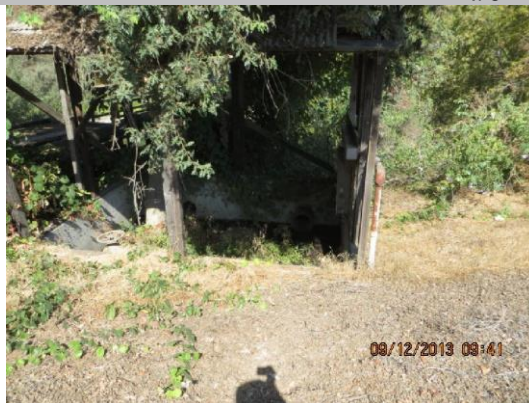
Photo 1 of 3 : UCIP_SP_2019_20683_34782.jpg

Pipe visible inside pumphouse on WS slope.

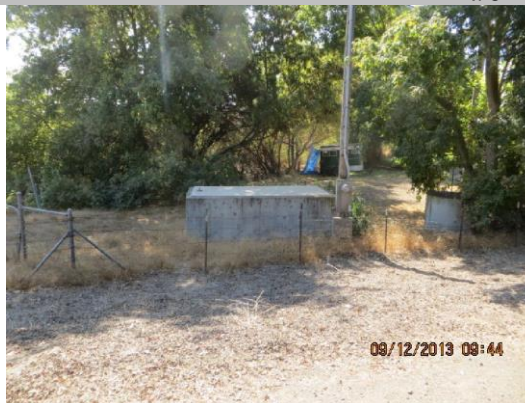
Photo 3 of 3 : UCIP_SP_2019_20683_34780.jpg

Concrete distribution box on LS toe.

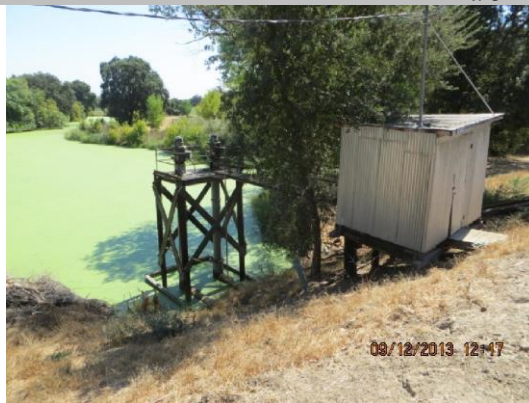
Photo 1 of 3 : UCIP_SP_2019_20703_34822.jpg

Pump on platform at LS toe.

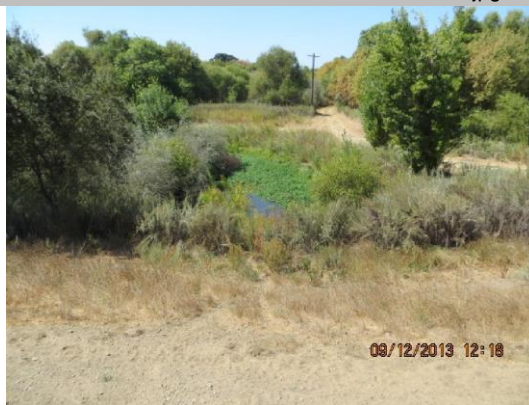
Photo 2 of 3 : UCIP_SP_2019_20703_34821.jpg

Pond at outlet on WS toe.

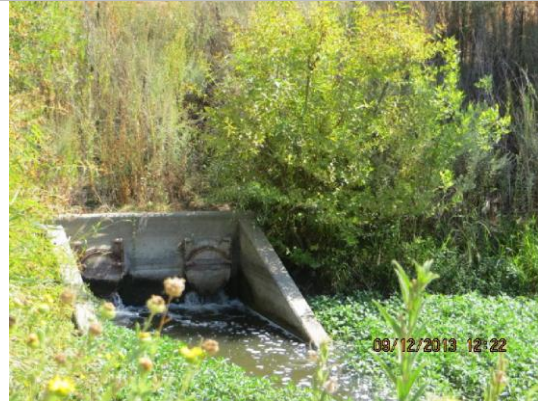
Photo 3 of 3 : UCIP_SP_2019_20703_34820.jpg

Concrete U-shaped headwall with flapgate on WS toe.

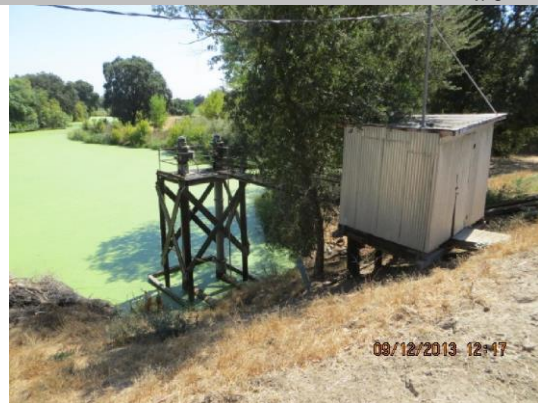
Photo 1 of 3 : UCIP_SP_2019_20704_34826.jpg

Pump on pier on LS toe with shed at pump walkway.

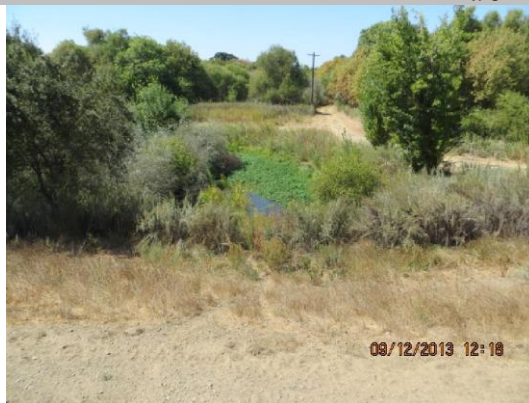
Photo 2 of 3 : UCIP_SP_2019_20704_34825.jpg

Pond at outlet on WS toe.

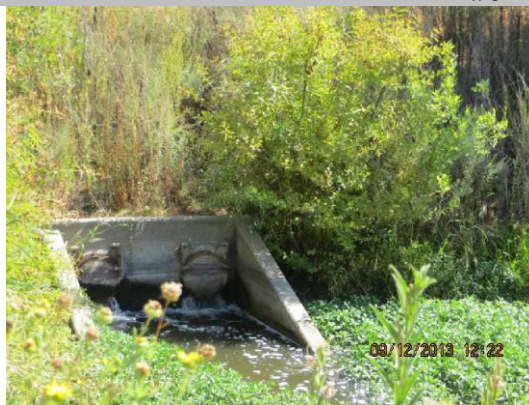
Photo 3 of 3 : UCIP_SP_2019_20704_34824.jpg

Flap gate at Concrete outlet on WS toe.

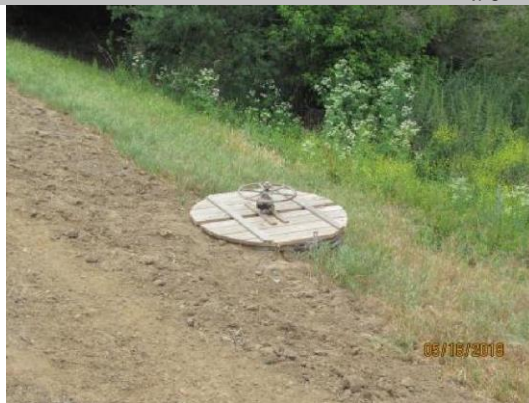
Photo 1 of 3 : UCIP_SP_2019_53836_77560.jpg

5/17/2018- Newly installed lid.

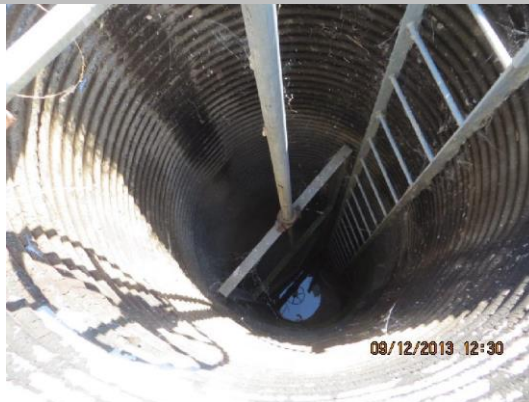
Photo 2 of 3 : UCIP_SP_2019_53836_34834.jpg

Slide gate in CMP riser on WS slope.

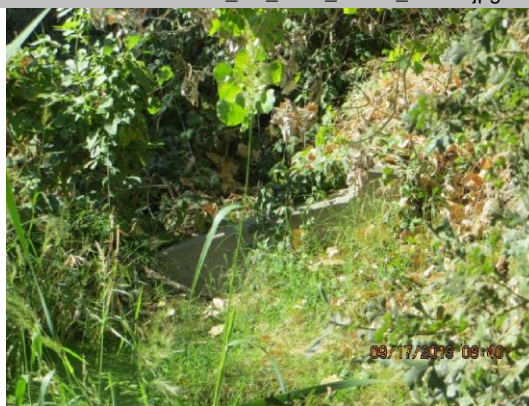
Photo 3 of 3 : UCIP_SP_2019_53836_34833.jpg

Concrete headwall on LS toe at edge of pond.

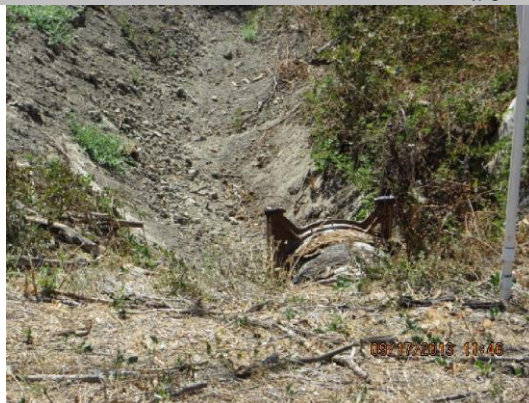
Photo 1 of 3 : UCIP_SP_2019_20723_34882.jpg

Flap gate on CMP pipe at WS toe.

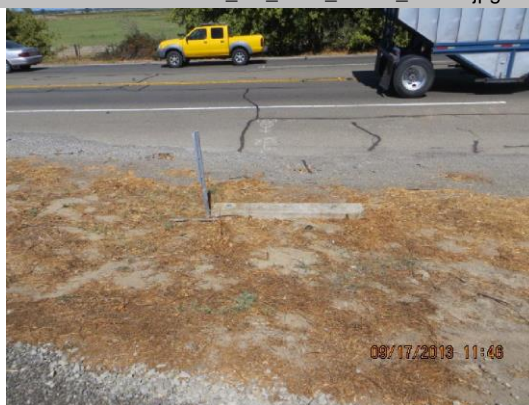
Photo 2 of 3 : UCIP_SP_2019_20723_34881.jpg

Concrete headwall on LS toe.

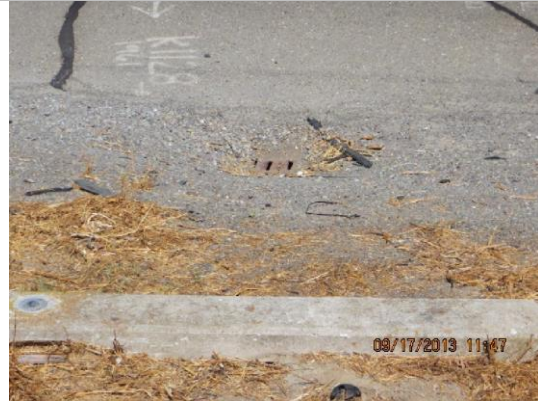
Photo 3 of 3 : UCIP_SP_2019_20723_34880.jpg

Drop inlet on LS toe.

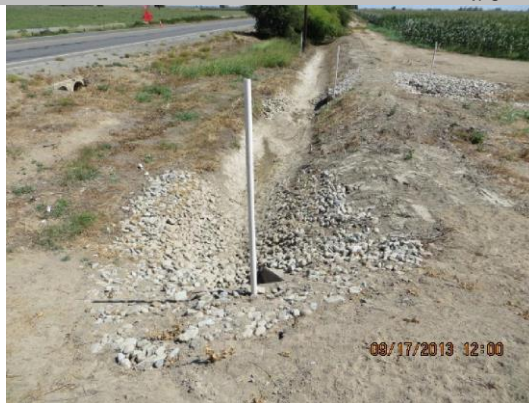
Photo 1 of 3 : UCIP_SP_2019_51374_34886.jpg

Concrete headwall on LS toe.

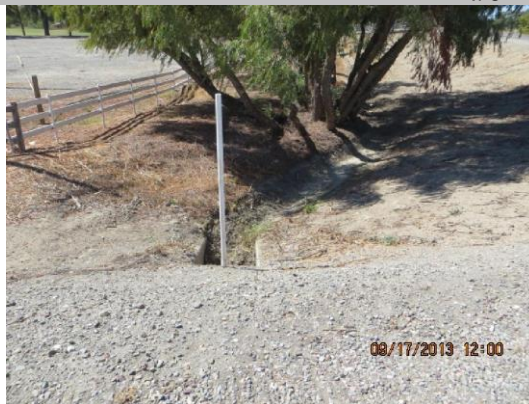
Photo 2 of 3 : UCIP_SP_2019_51374_34885.jpg

Concrete headwall on WS toe.

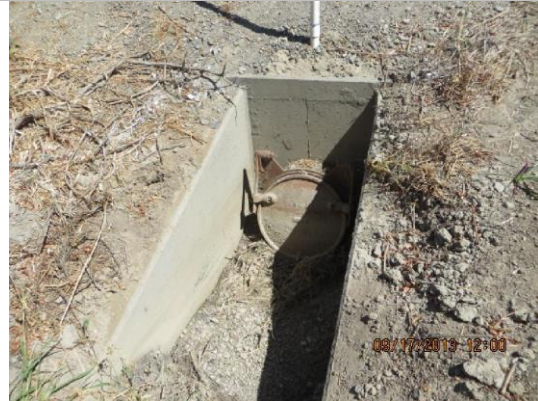
Photo 3 of 3 : UCIP_SP_2019_51374_34884.jpg

Flapgate on WS toe.

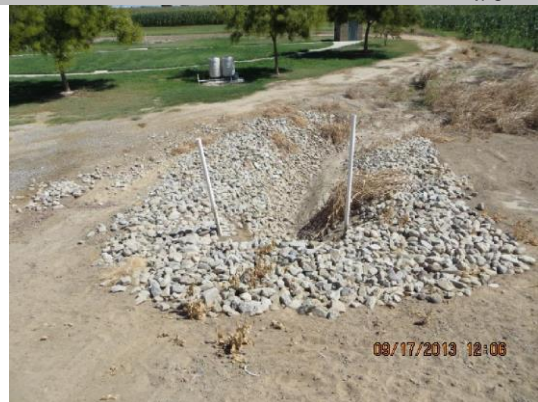
Photo 1 of 3 : UCIP_SP_2019_20728_34895.jpg

Concrete headwall at ditch on LS toe.

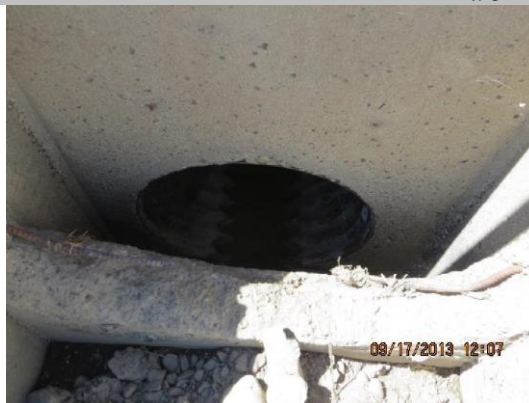
Photo 2 of 3 : UCIP_SP_2019_20728_34894.jpg

Concrete headwall on LS toe.

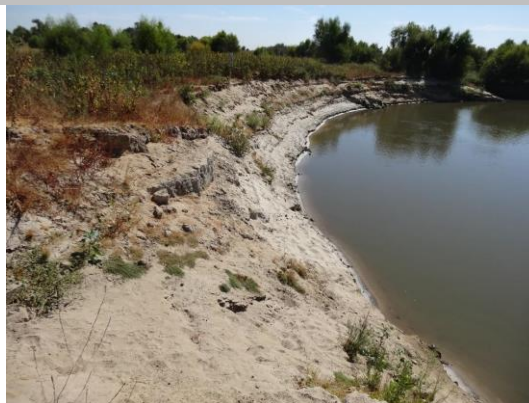
Photo 1 of 4 : SP_2019_RD2031_308_1_20190313_00001.jpg

Looking upstream of the erosion site.

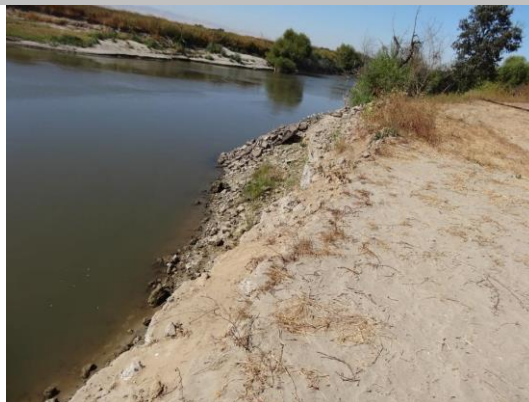
Photo 2 of 4 : SP_2019_RD2031_308_1_20190313_00002.jpg

Looking downstream of the erosion site.

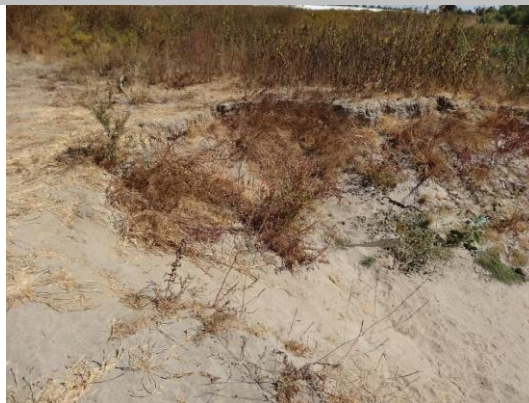
Photo 3 of 4 : SP_2019_RD2031_308_1_20190313_00003.jpg

Close view of the pocket erosion.

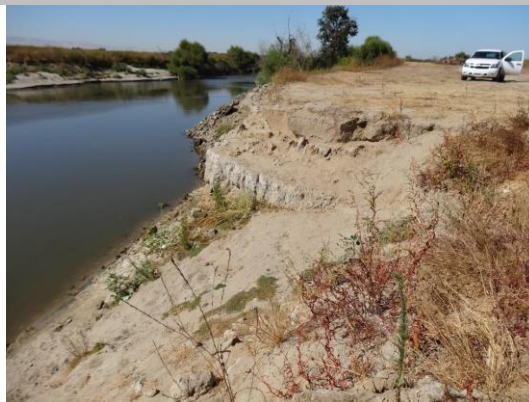
Photo 4 of 4 : SP_2019_RD2031_308_1_20190313_00004.jpg

Close view of the erosion.
